Manhole Inspection Summary

Manhole # S29Q__008MH

Insp Date: **11/4/08 9:12 AM**

Location Address: **611 Ridgley St**

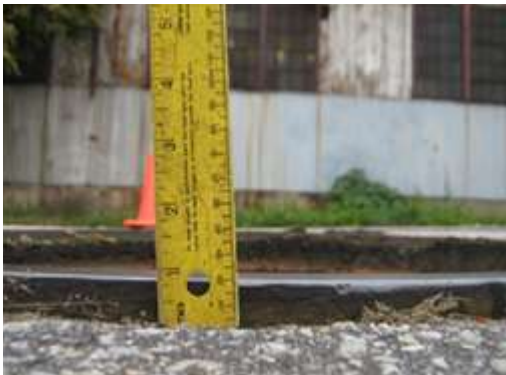
misc

A/B grade .75"

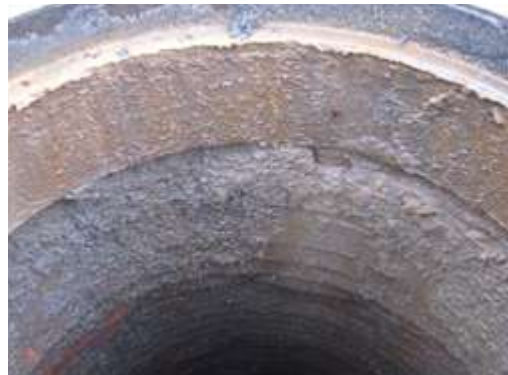
Defect 2

Condition: ☒ Sound ☐ Cracked ☒ **Leaks**

Infiltration: ☐ None ☒ **Joint** ☐ Cracks ☐ Mortar ☐ Roots ☐ Wall

frame leaks, infiltration from chimney joint

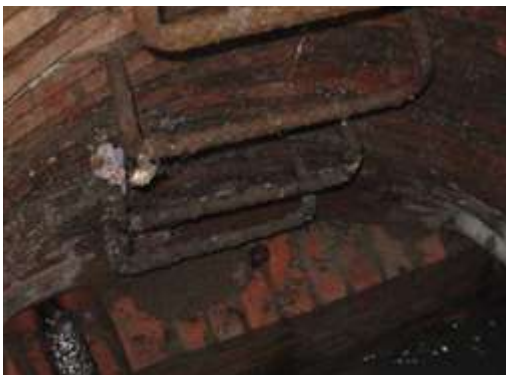
Defect 1

Count: **5** Missing: **0** ☒ **Corroded**

☒ **Evidence Of Surcharge** Depth: **4** (ft.) ☐ Active Surcharge Present

Corroded rungs; evidence of surcharge

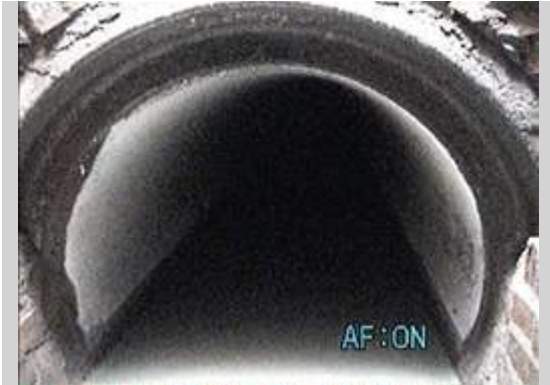
12 O'Clock Outflow

39 in. Circular Gravity Sewer
Pipe Out @ 12 O'Clock

Pipe Height: **36** (in.) Rod and Bar (Angled)
Pipe Material: **Clay** ☐ Pipe Lined
Invert Depth: **11.24** (ft.) Flow Characteristics: **Slow**
Deposits: ☒ None ☐ Mud ☐ Sludge ☐ Debris ☐ Grease
Silt Depth: **0** (in.) Deposits Extent:
Infiltration: **None** Pipe Seal Cond: **Sound**

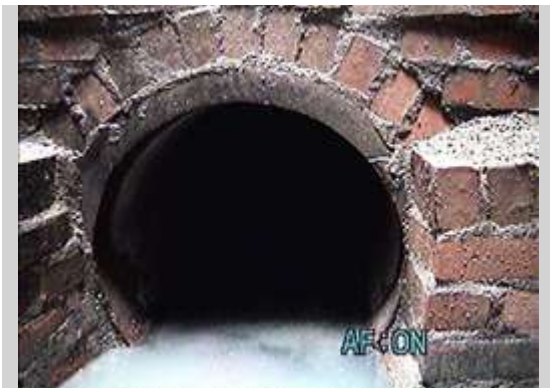
3 O'Clock Inflow

21 in. Circular Gravity Sewer
Pipe In @ 3 O'Clock

Pipe Height: **20.4** (in.) Rod and Bar (Angled)
Pipe Material: **Clay** ☐ Pipe Lined
Invert Depth: **10.70** (ft.) Flow Characteristics: **Slow**
Deposits: ☒ None ☐ Mud ☐ Sludge ☐ Debris ☐ Grease
Silt Depth: **0** (in.) Deposits Extent:
Infiltration: **None** Pipe Seal Cond: **Sound**

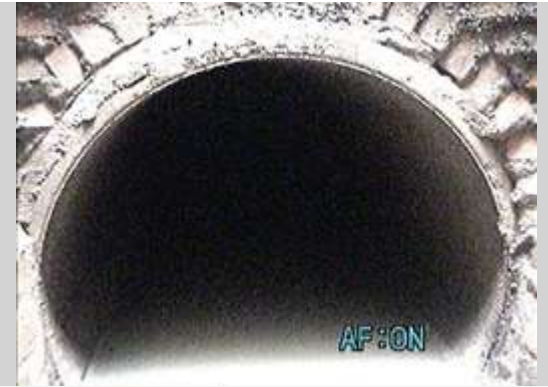
6 O'Clock Inflow

Pipe Height: **36** (in.) Rod and Bar (Angled)

Pipe Material: **Clay** ☐ Pipe Lined

Invert Depth: **11.19** (ft.) Flow Characteristics: **Slow**

Infiltration: **None** Pipe Seal Cond: **Sound**

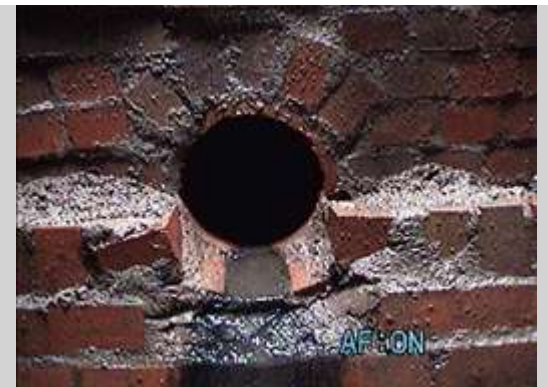
9 O'Clock Inflow

Pipe Height: **8.4** (in.) Rod and Bar (Angled)

Pipe Material: **Clay** ☐ Pipe Lined

Invert Depth: **9.55** (ft.) Flow Characteristics: **Slow**

Infiltration: **None** Pipe Seal Cond: **Sound**
